FAILURE ANALYSIS HANDBOOK

C. R. Walker, K. K. Starr

Pratt & Whitney
P.O. Box 109600
West Palm Beach, FL 33410-9600

August 1989

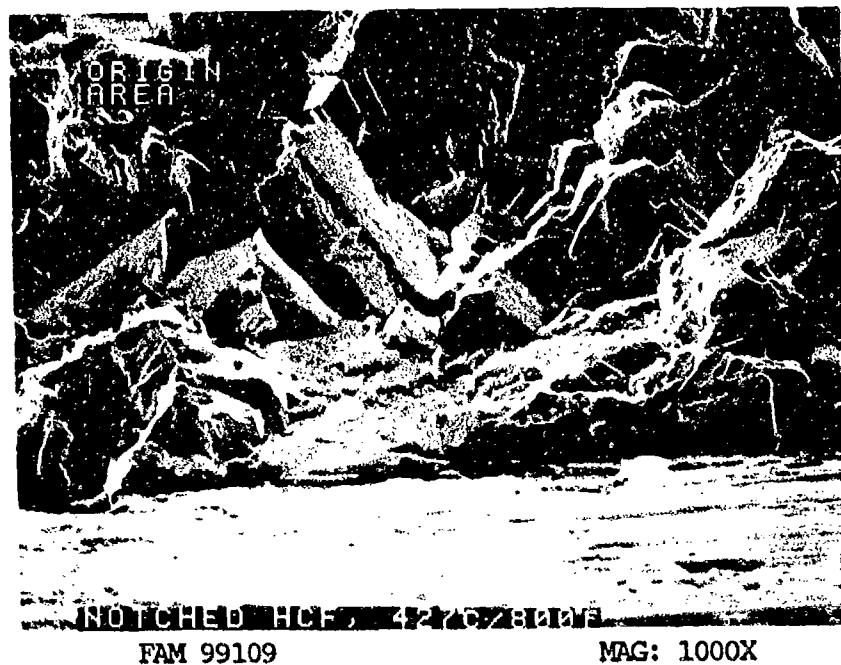
FIGURE 9-79: Stage I facet at the origin. No fatigue striations are visible on the facet in the Stage I area even at high magnifications.

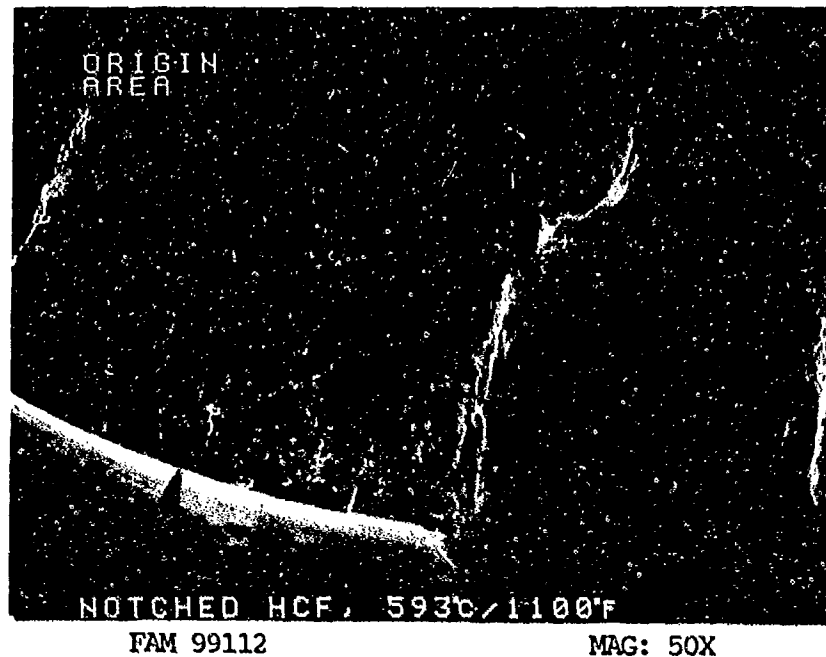
FIGURE 9-88: One of several fatigue origins separated by fatigue steps. Features can be seen radiating from a small localized (point) origin (arrow).

FIGURE 9-89: Higher magnification photograph of the localized origin area shown in Figure 9-88. No defects are visible at the origin (arrow).

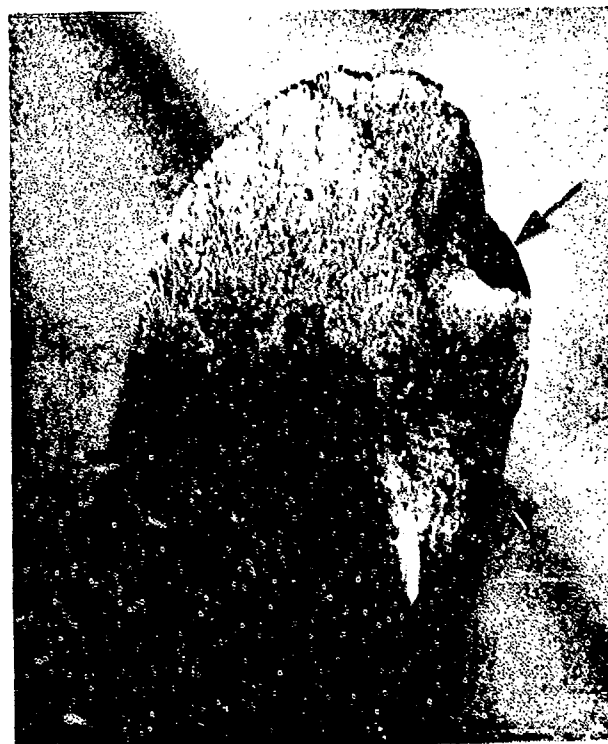
FAL 93214

FIGURE 9-106: Test results and fractography of Inconel X-750 593°C (1100°F) smooth LCF test. Two thumbnails are visible on opposite sides of the specimen (arrows). These thumbnails are roughly perpendicular to the stress axis. The remainder of the fracture occurred at an angle to the stress axis.

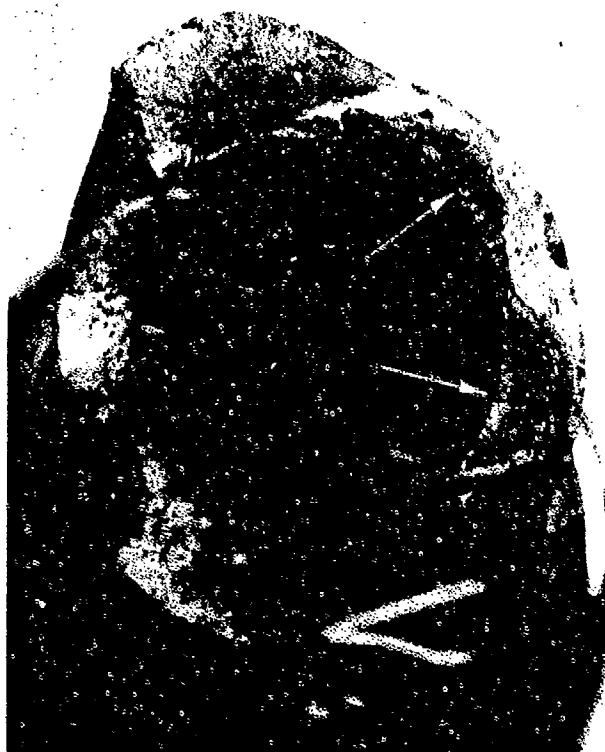
FAL 94287

FIGURE 9-124: Test results and fractography of Inco X-750 Out-of-Phase TMF test. Two oxidized fatigue progression zones (thumbnails) are visible at the I.D. surface of the specimen (arrows). Arrest marks can be seen within the thumbnails.

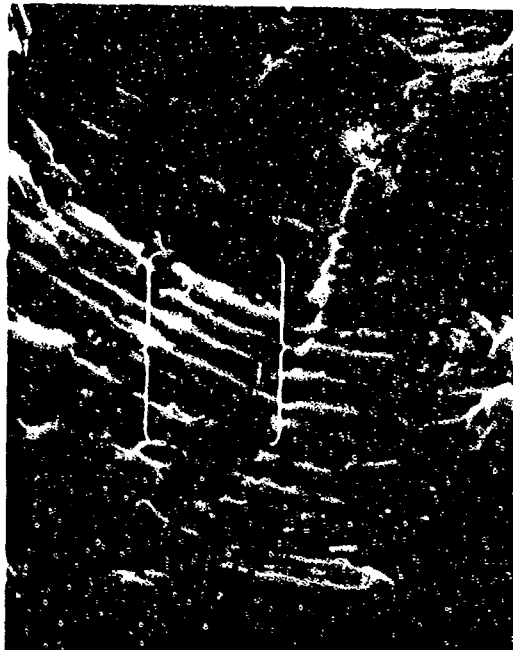
FAL 93344

FIGURE 9-138: Higher magnification photograph of the fatigue striations. The curvature of the striations with their concave side up indicates propagation from top to bottom of the photograph.

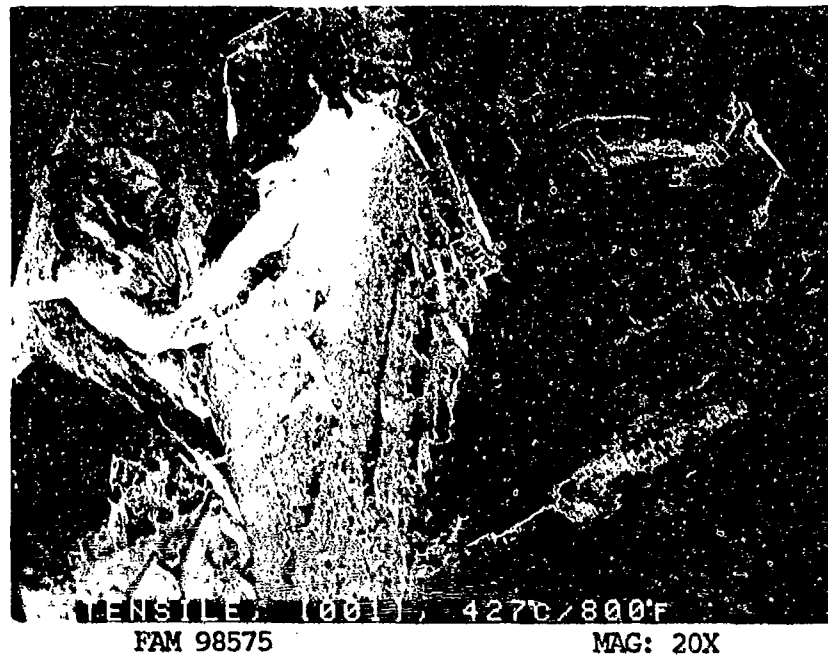
FIGURE 10-3: Low magnification photograph showing the faceted appearance of the fracture. This is the result of fracture along close-packed crystallographic planes.

FIGURE 10-4: Higher magnification photograph of the area shown in Figure 10-3, showing abrupt changes in fracture path (arrows) associated with fracture along close-packed planes.

FIGURE 10-10: Low magnification photograph showing the non-crystallographic nature of the fracture. Compare with the 800°F specimen, Figures 10-3 through 10-5.

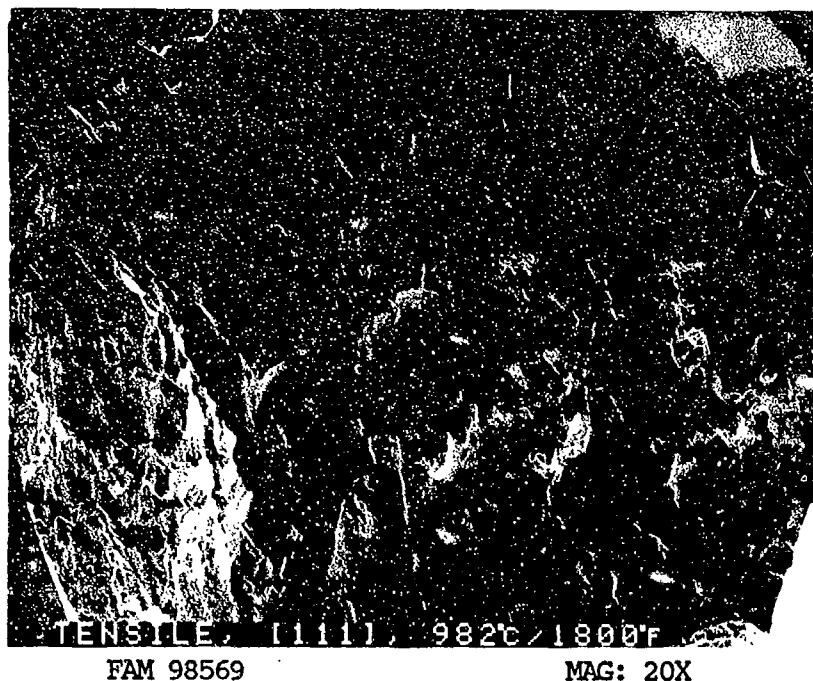
FIGURE 10-22: Low magnification photograph showing jagged appearance of the fracture.

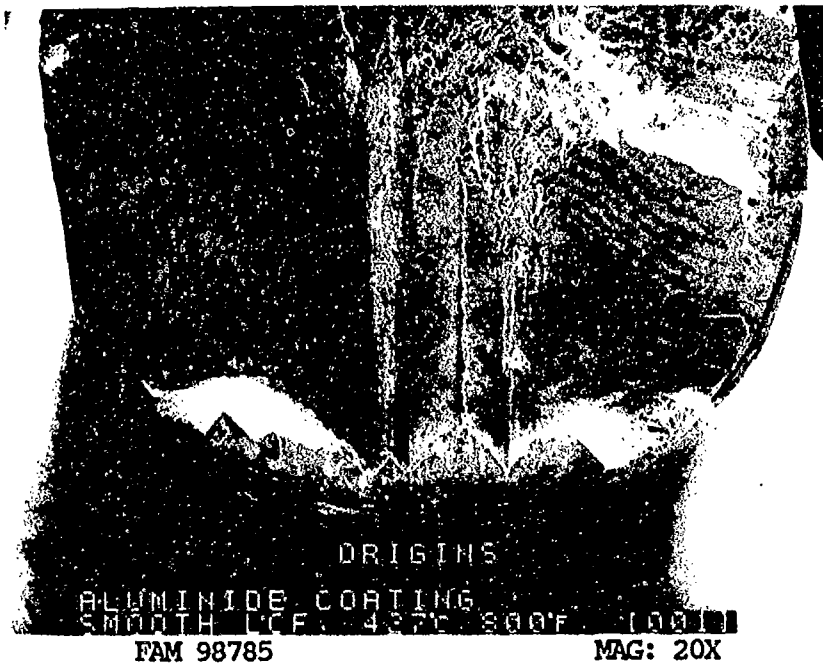
FIGURE 10-33: Low magnification photograph showing arrest marks (arrows A) indicating fatigue propagation from several origins near the bottom of the photograph (arrows B).

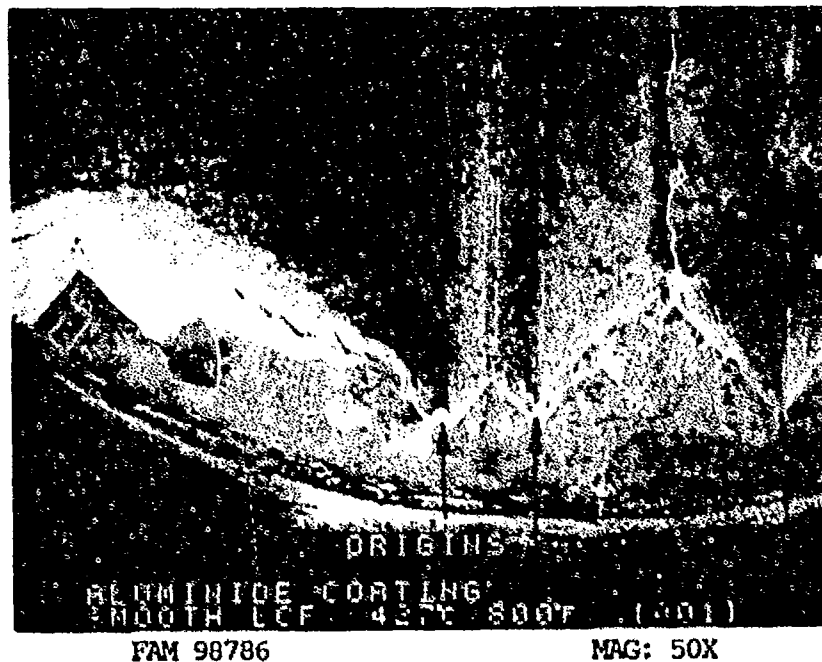
FIGURE 10-34: Higher magnification photograph showing three fatigue origins near the surface of the specimen (arrows).

FIGURE 10-35: Close-up photograph of the origin area shown in Figure 10-34. The extent of the coating is shown by arrows.

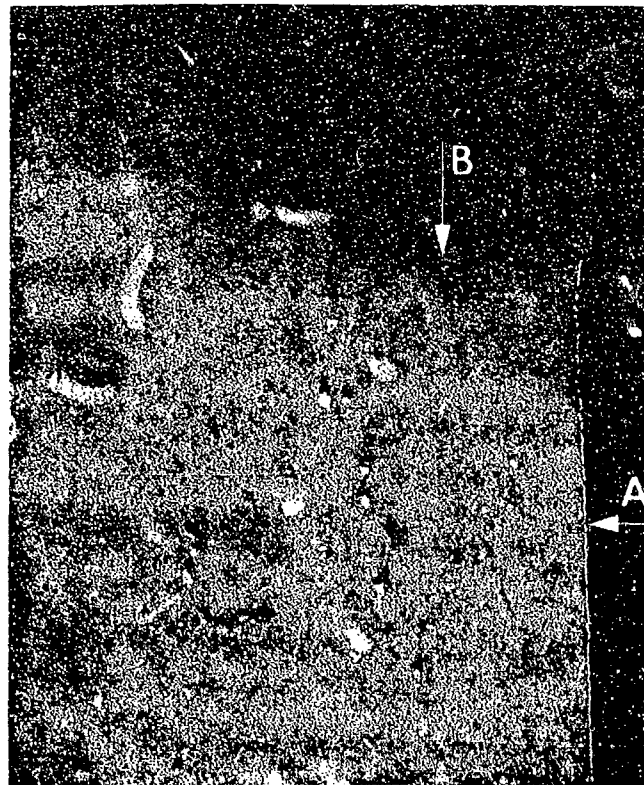
FIGURE 10-43: Optical photomicrographs showing fatigue propagation area (top) and final overstress area (bottom). The fatigue progression is flatter while the overstress is more jagged. A thin alloy depleted layer is visible on the exposed gage section (arrow A) and on the fatigue progression area (arrow B). The fatigue area was exposed to the high temperature oxidizing environment (hot air) during propagation.

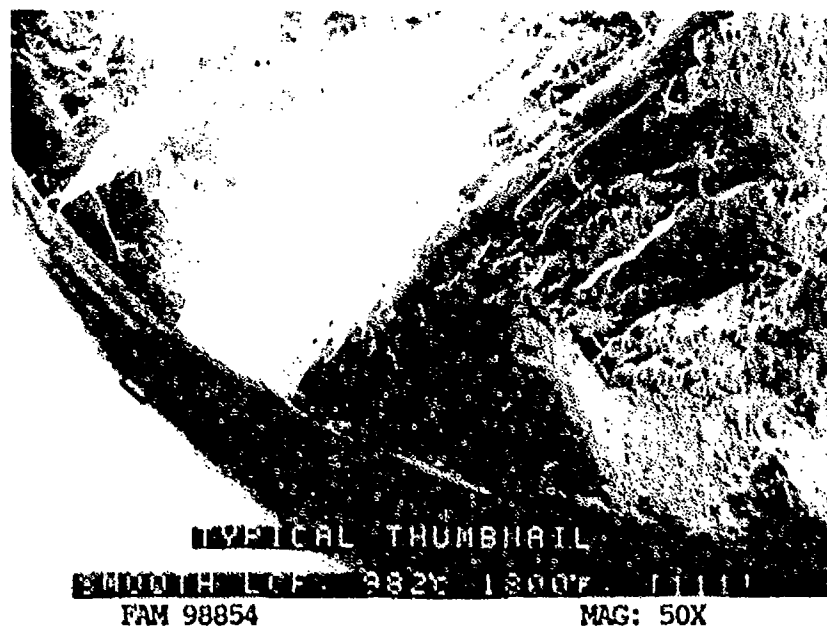
FIGURE 10-52: Close-up photograph showing a typical origin area. A localized origin is indicated by an arrow.

FIGURE 10-53: Higher magnification photograph of the area shown in Figure 10-52, showing a small void at the origin. No striations are visible in the origin area.

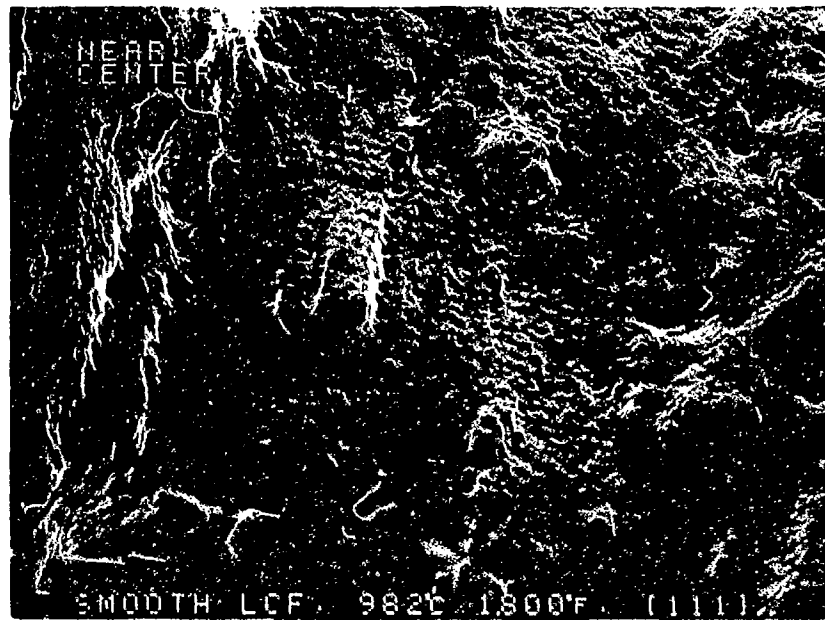
FIGURE 10-55: Fatigue progression near the center of the fracture surface. Coarse striations are visible. The direction of propagation is shown by an arrow.

FIGURE 10-56: Higher magnification photograph of the coarse oxidized striations shown in Figure 10-55.

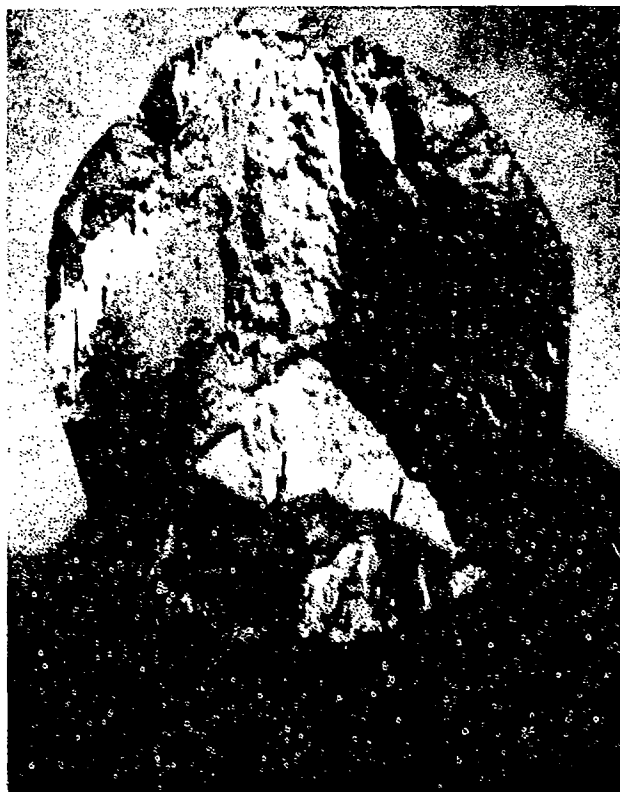
FIGURE 10-59: Test results and fractography of FWA 1480/[001] Out-of-Phase TMF test. An oxidized (dark) fatigue progression zone is visible at the bottom of the photograph. Arrows indicate the extent of the fatigue.

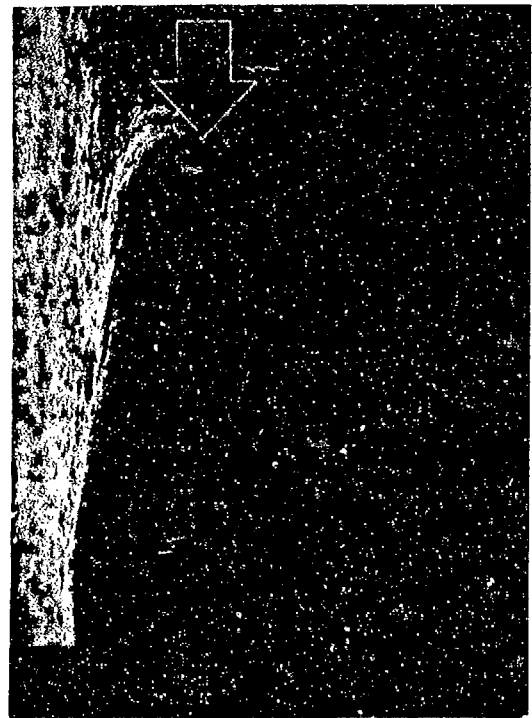
FAL 93449

FIGURE 10-74: Close-up of the primary origin area exhibiting only heavy oxidation.

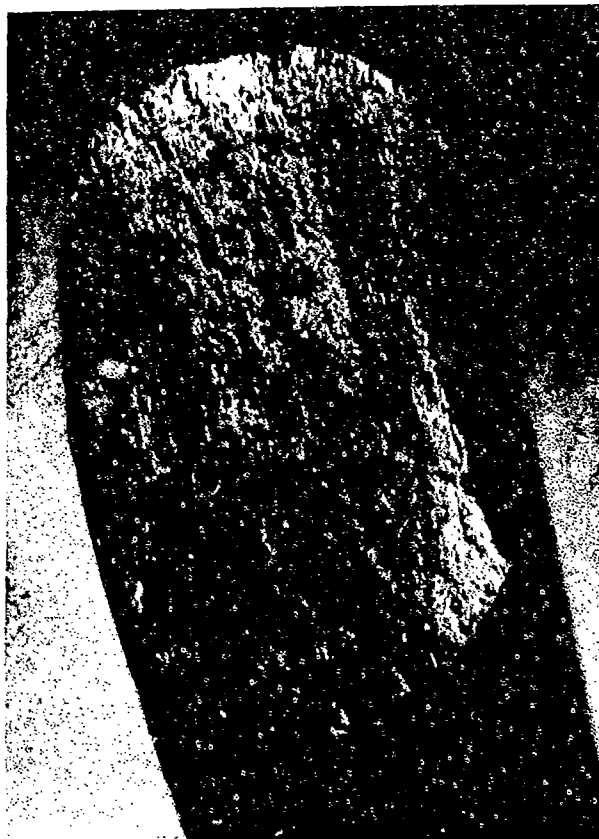
FAL 94242

0.2% Yield Strength: 1323.8 MPa (192 ksi)
Ultimate Strength: 1392.7 MPa (202 ksi)

FIGURE 11-1: Test results and fractography of MP-159 593°C (1100°F) smooth tensile test. The fracture surface was oriented at an angle of approximately 45° to the stress axis.

Notched and smooth tensile tests were run at 1100°F. The smooth specimen fractured on a 45° angle to the stress axis and exhibited shallow shear dimples over the entire fracture. The notched specimen exhibited coarse deep equiaxed dimples in the center of the specimen and shallow equiaxed and shear dimples in the final overstress area. Particles were visible associated with some of the dimples in both areas. The stress rupture specimen exhibited deep features macroscopically but shallow dimpled rupture on a microscopic scale. Deep voids and second phase particles were visible in the fracture composed of very shallow equiaxed dimples in the primary rupture area and shear dimples near the edge of the specimen.

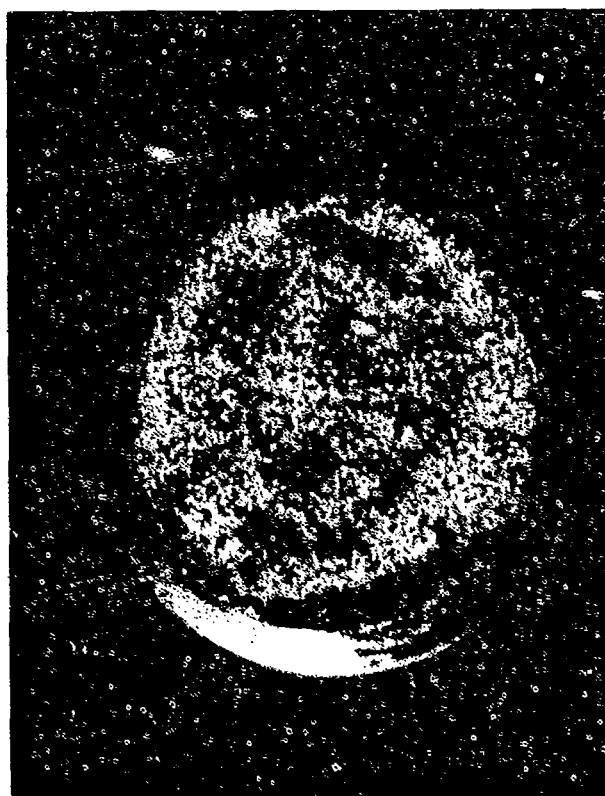
FAL 94238

FIGURE 11-7: Test results and fractography of MP-159 593°C (1100°F) notched tensile test. The fracture surface has a granular appearance.

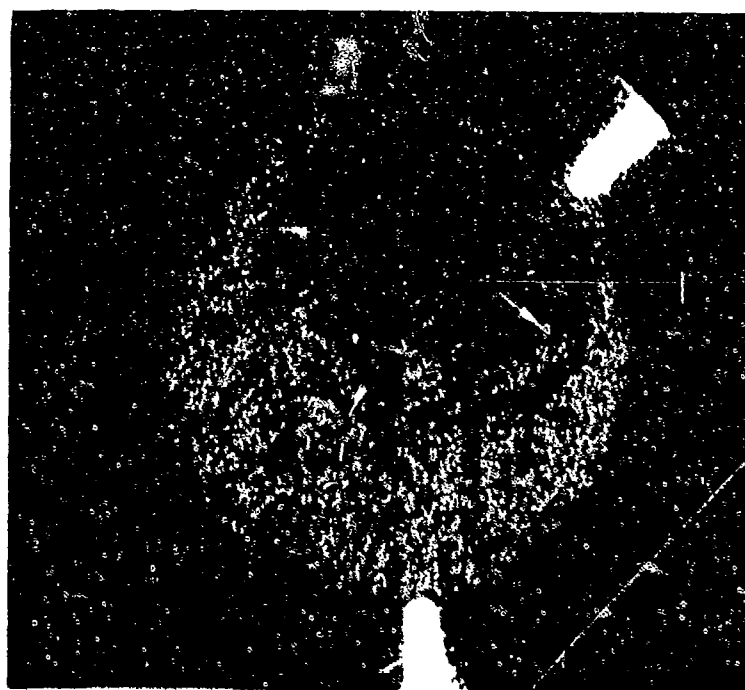
FAL 94379

Cycles to Fracture: 9700

FIGURE 11-55: Test results and fractography of MP-159 room temperature notched LCF test. The fatigue propagated from along the surface in a crescent extending 75% of the way around the specimen. The final overstress area is a circular shaped region exhibiting coarser features. The extent of the fatigue is shown by arrows.

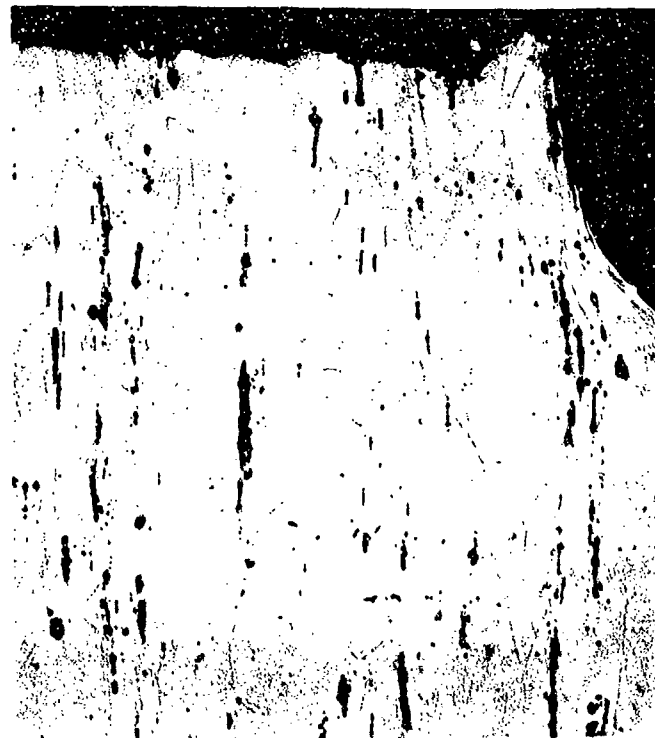
FIGURE 11-56: Optical photomicrographs showing the fatigue progression area (top) and the final overstress area (bottom). The fatigue progressed with little grain deformation in the grains adjacent to the fracture. Final overstress area exhibits grain deformation and dimpled overstress features. The fatigue progression is predominantly transgranular.

Etchant: HCl and H₂O₂ electrolytic

FIGURE 11-66: Optical photomicrographs showing the fatigue progression area (top) and the final overstress area (bottom). The fatigue progressed with little grain deformation in the grains adjacent to the fracture. The final overstress area exhibits grain deformation and dimpled overstress features. The appearance of the fracture path is transgranular, very similar to the room temperature specimen (Figure 11-56).

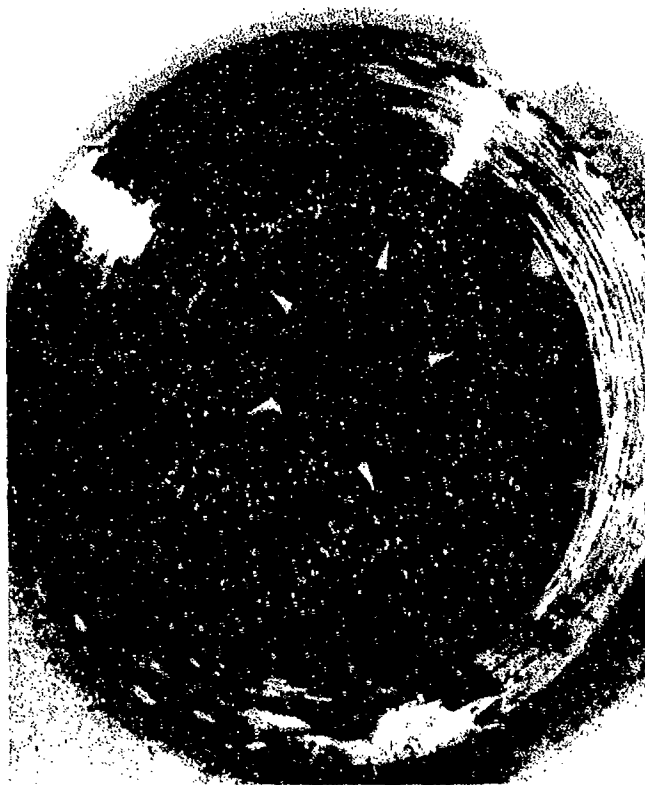
MAG: 14X

Cycles to Fracture: 3100

FIGURE 11-65: Test results and fractography of MP-159 593°C (1100°F) notched LCF test. The fatigue propagated from along the base of the notch 360° around the specimen. Arrowheads indicated the extent of the fatigue. The final overstress occurred roughly near the center of the specimen, exhibiting coarser features.

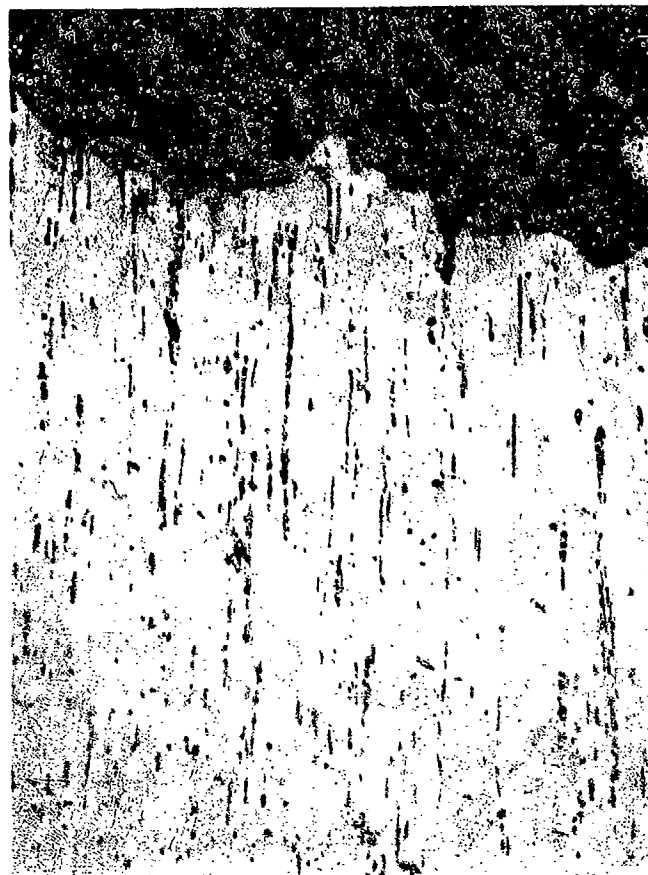
MAG: 100X

FIGURE 11-76: Optical photomicrograph showing dimpled overstress features in the final overstress area.

Etchant: HCl and H_2O_2 electrolytic

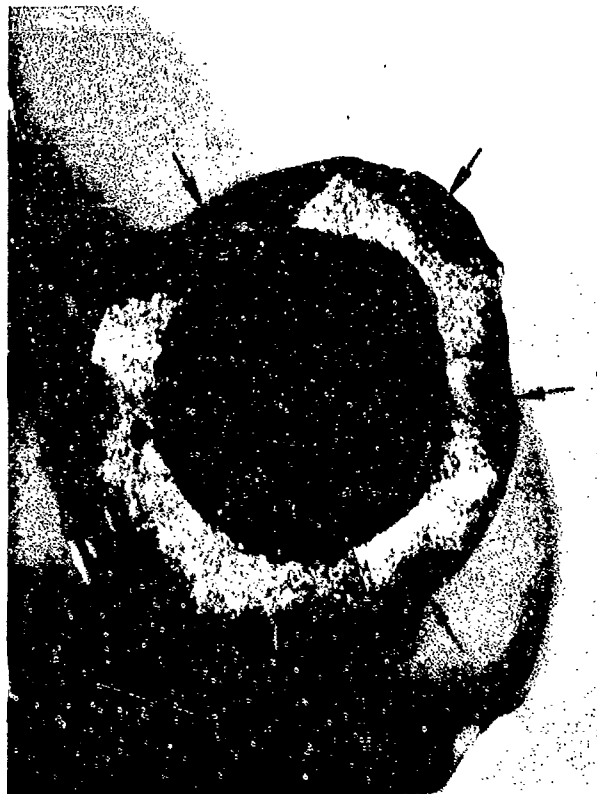
MAG: 8X

Cycles to Fracture: 3390

FIGURE 11-79: Test results and fractography of MP-159 in-phase TMF test. Seven thumbnails are visible propagating from origins (arrows) along the outside surface of the specimen. The thumbnails appear to be heavily oxidized.

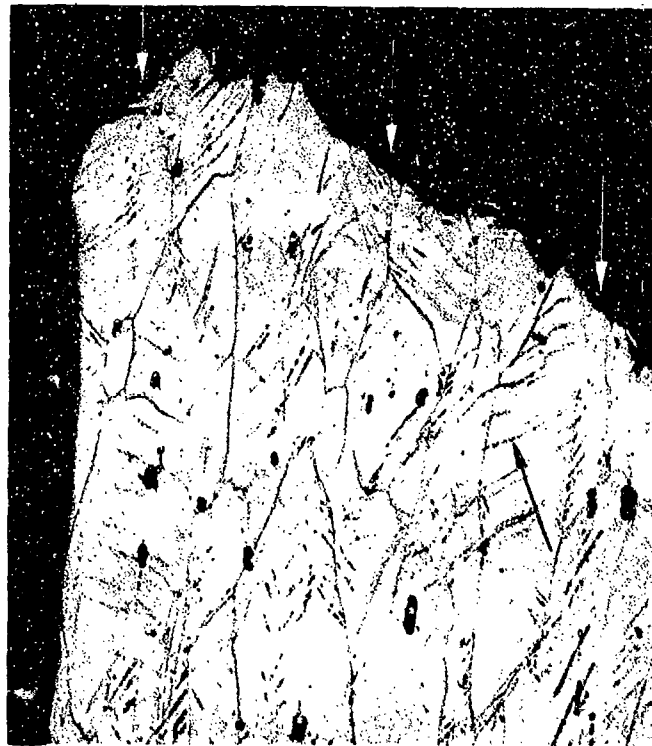
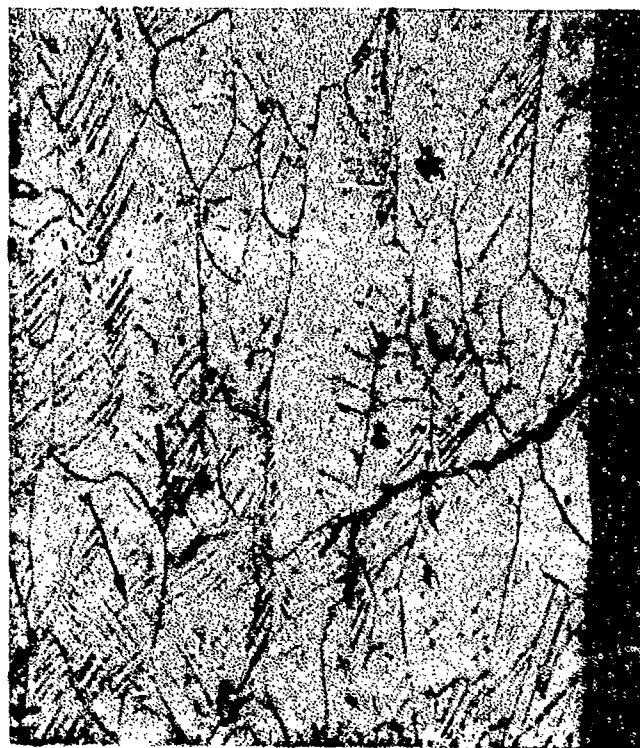
FIGURE 11-80: Optical photomicrographs showing a primary thermal-mechanical fatigue progression area (top) and a secondary crack in the gage section (bottom). Strain lines are visible in both photographs (arrows). The primary progression surface exhibits oxidation (white arrows, top).

Etchant: HCl and H_2O_2 electrolytic

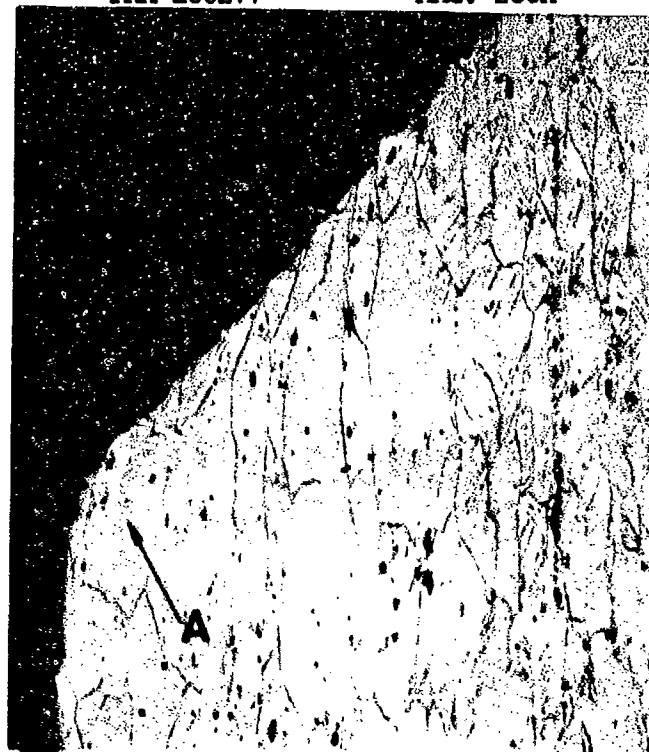
FIGURE 11-90: Optical photomicrographs showing the primary thermal-mechanical fatigue progression area and a secondary crack in the gage section (top) and the final overstress area oriented at an angle to the stress axis (bottom). Strain lines are visible in both photographs (arrows A). The primary progression surface exhibits oxidation (arrows B).

Etchant: HCl and H_2O_2 electrolytic

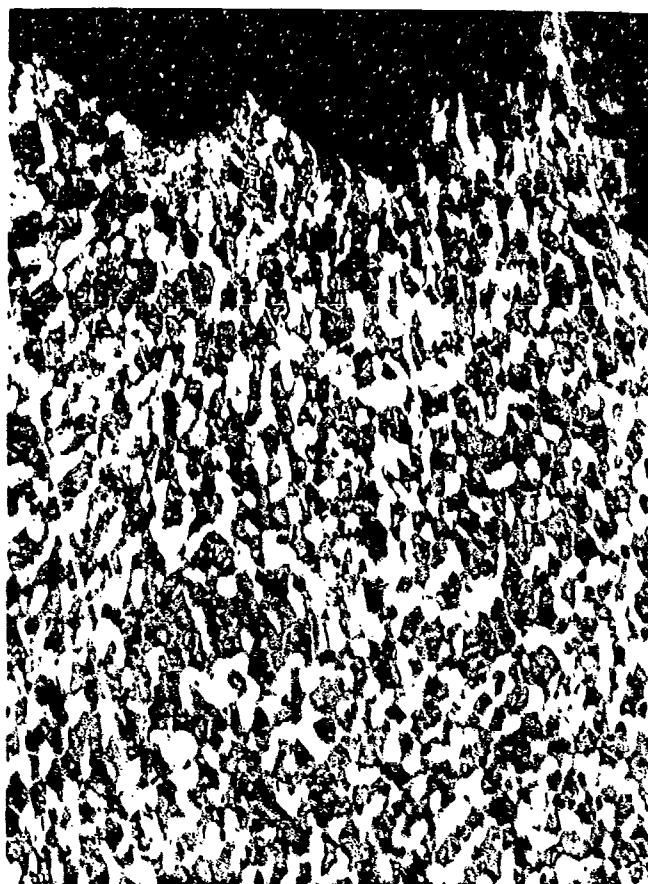
FAM 99788

FIGURE 12-24: Optical photomicrograph of the base of the notch (arrow). The final overstress area is the only region exhibiting elongated grains. Just inboard of the notch, the grains are equiaxed. The grains remain equiaxed adjacent to the fracture surface, indicating that little or no plastic deformation accompanied the fracture.

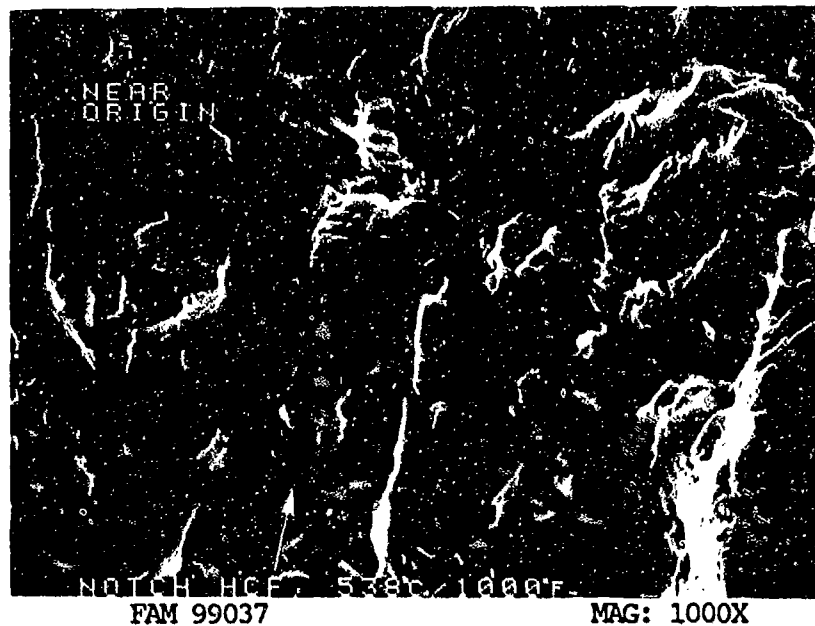
FIGURE 12-84: Fine fatigue striations near the origin. The fracture propagated from bottom to top of the photograph. Arrow indicates a patch of remnant striations.

FIGURE 12-85: High magnification view of the fine striations shown in Figure 12-84. Individual striations are barely resolvable. Bracket contains five striations.

FIGURE 12-87: Higher magnification view of the oxidized striations shown in Figure 12-84.

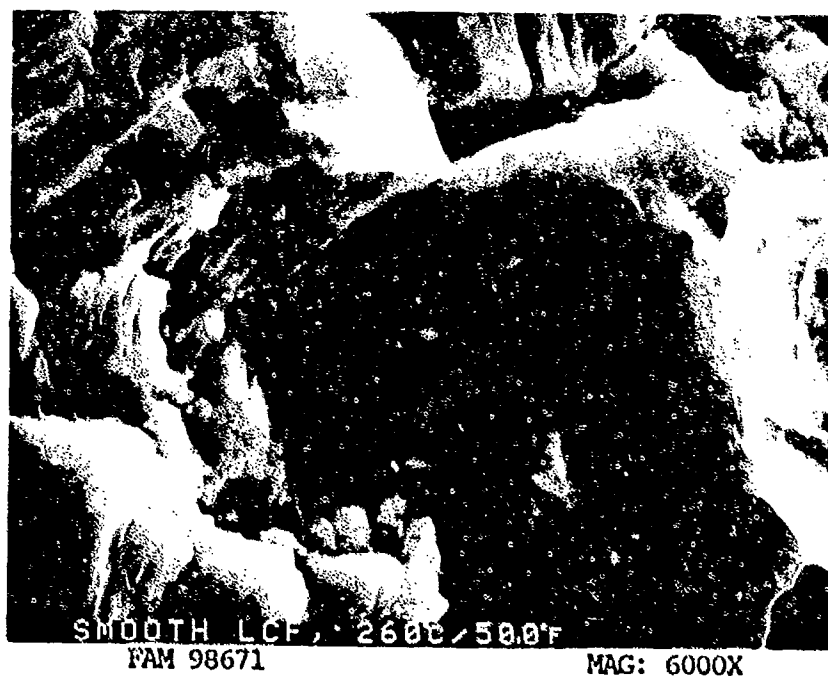
FIGURE 12-97: High magnification photograph showing remnant fatigue striations. The direction of propagation is shown by an arrow.
